Home Inspection
for

Inspected By:

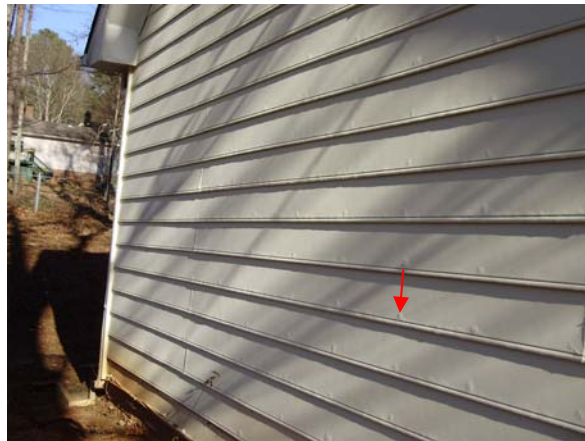
Swelling was present around the nail heads and along the lower edge of various pieces of siding on the left side of the garage.

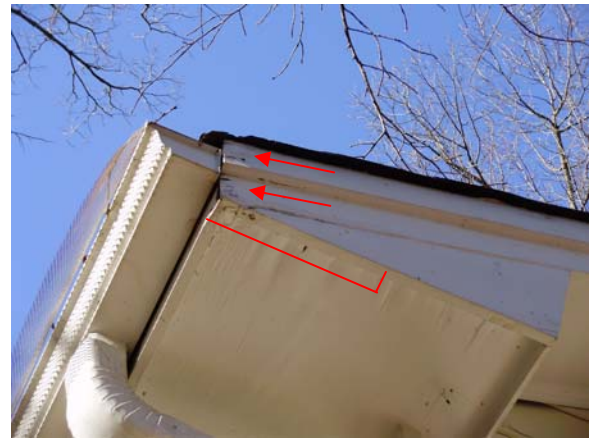
Moisture damage was noted at the fascia/soffit boards behind the gutter at the right corner of the front porch.

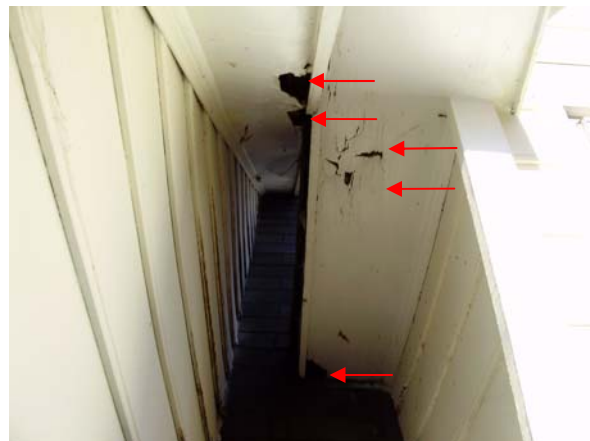
Rodent access holes and moisture damage was noted at the soffit boards on the left side of the left dormer on the front of the home.

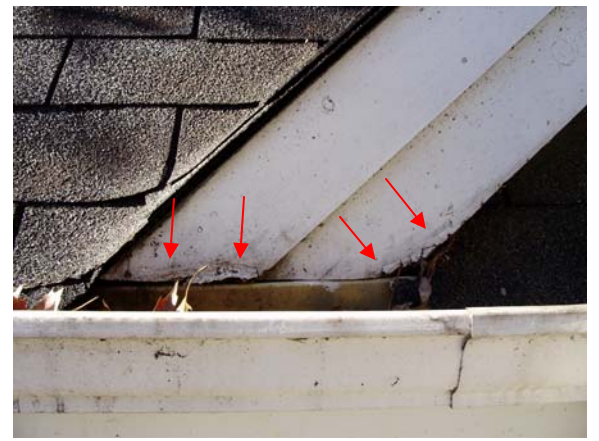
Moisture damage was noted at the fascia boards above the gutter at the bottom of the roof valley above the right wall of the master bedroom.

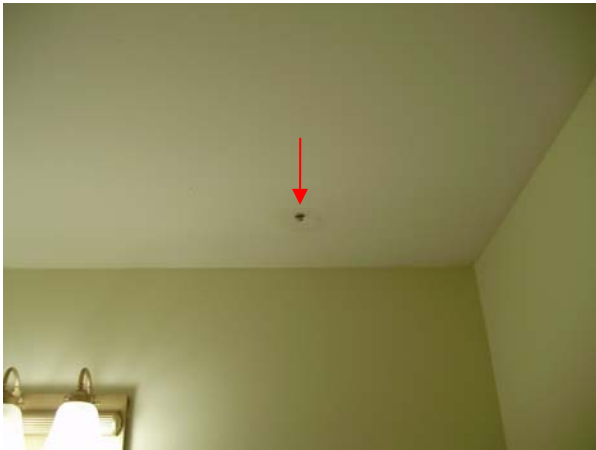
Moisture damage was noted at the sheetrock ceiling above the commode in the half bath, due to an active leak at the commode in the upstairs hall bathroom.

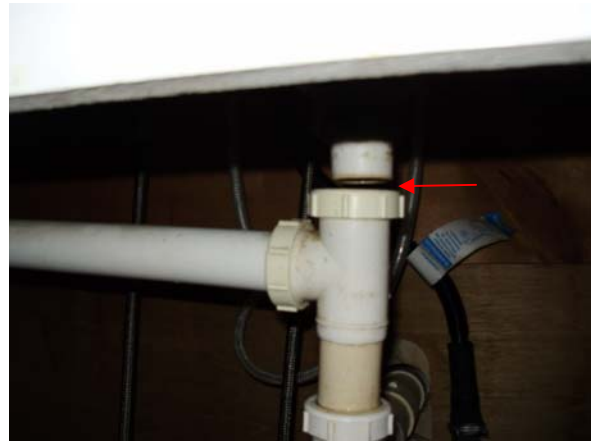
Connect the loose plumbing drainpipe below the right sink in the kitchen.

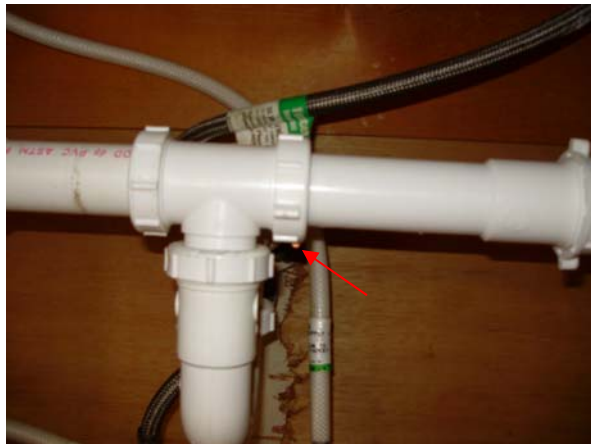
Repair the leak at the union in the plumbing drainpipe below the sinks in the master bathroom.

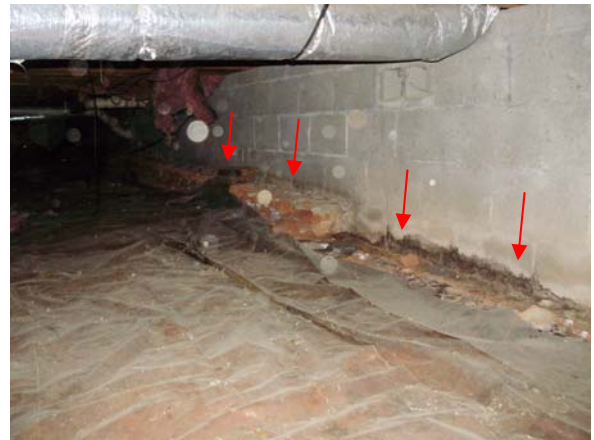
Past moisture stains were present on the lower portion of the rear foundation wall in the crawlspace.

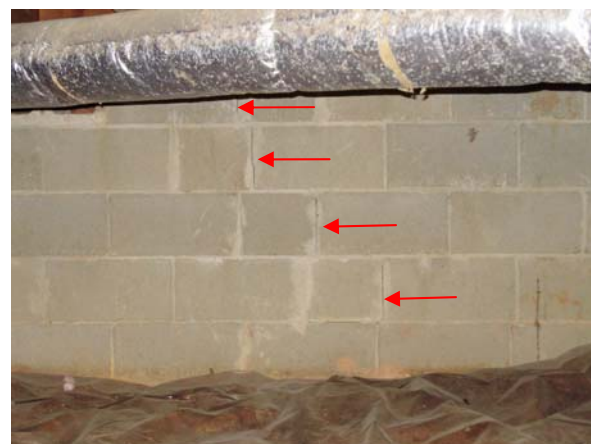
A settling crack present in the concrete block foundation wall below the bay window cavity in the master bedroom (visible in the crawlspace).

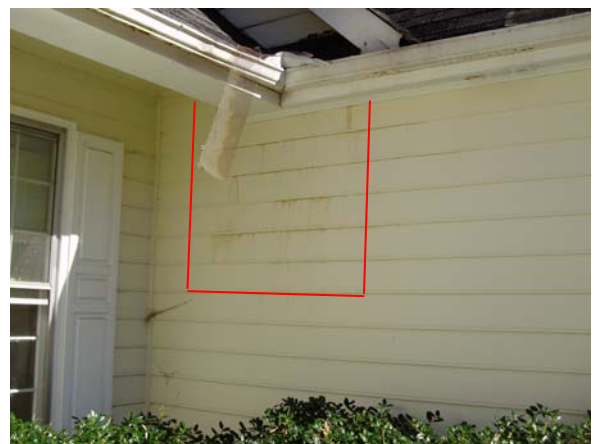
Several past moisture stains were present on the siding outside the left wall of the master bathroom.

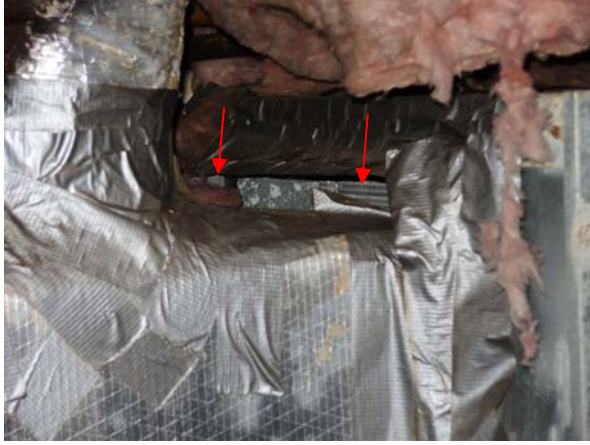
The supply plenum on the left side of the main floor furnace is loose (visible in the crawlspace).

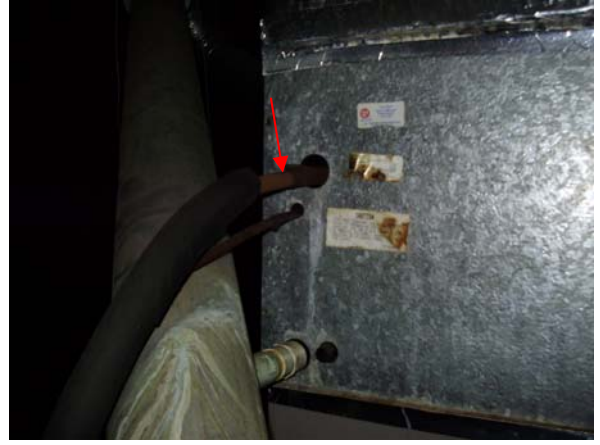
Additional insulation is needed at the voids around the refrigerant return line exiting the a/c evaporator coil in the attic.

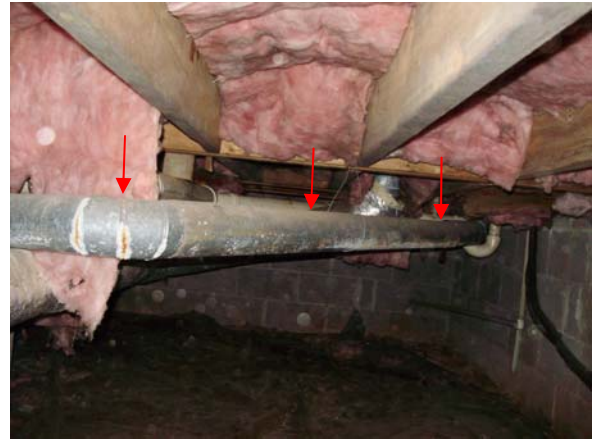
Surface rust was present on the exterior of the main floor furnace flue in the crawlspace.

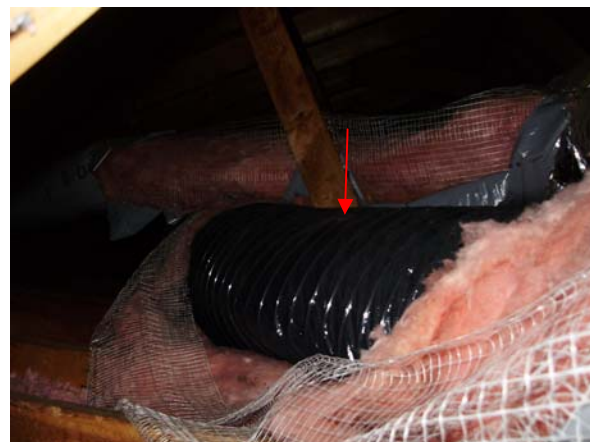
The insulation is damaged around several of the hvac supply ducts in the upper portion of the attic.

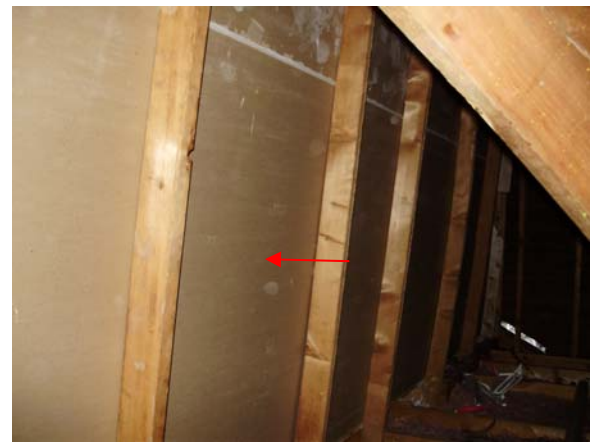
Recommend installing insulation in the left wall of the front, center room in the upper level of the home.

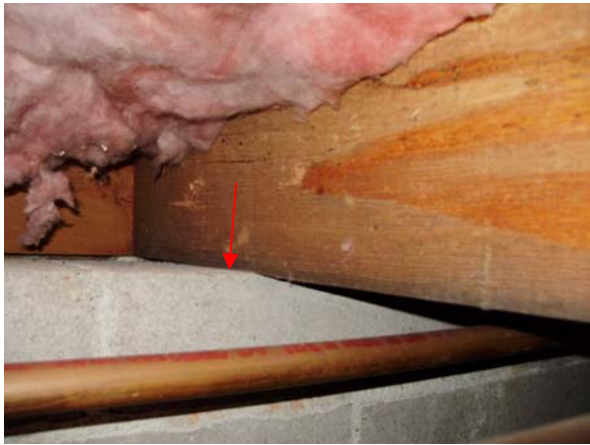
Pressure-treated sill plates were not installed above the foundation walls in the crawlspace.

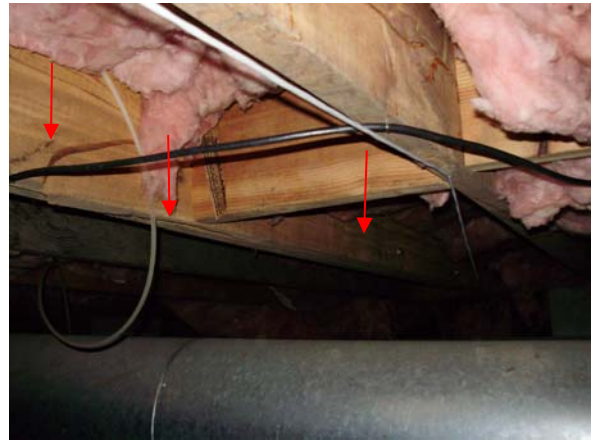
Additional support has been installed at the cracked floor joist below the center portion of the kitchen floor.
